MOBISEC

Study about safety of cyclists and pedestrians in crossroads and roundabouts

Deliverable D2.3

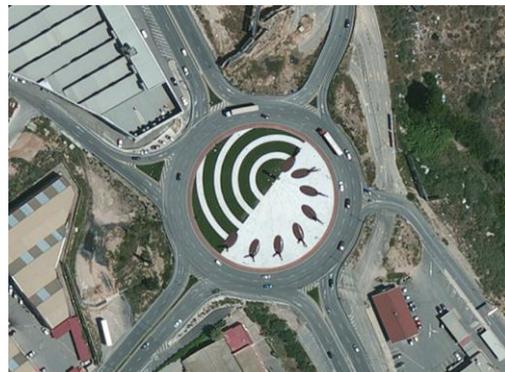
It consists of a roundabout with three large-diameter driving lanes with a large traffic absorption capacity, rather moderate longitudinal slopes, good visibility and ample entry and exit radiuses, all in consonance with its inter-city nature. The only defects are the non-existence of pavements and a bike lane, especially the latter as rather abundant cycling traffic was observed after the study conducted (mainly because of its proximity to the University and some nearby housing developments that generate heavier cycling traffic than would otherwise be expected).

Given its inter-city nature and the distribution of the traffic flows, it works without the need for any traffic lights and the state of conservation is very good both as far as the road surface as well as all of the existing vertical and horizontal signing.

Upon analysing the intersection from the perspective of the safety of a cyclist transiting through it, we find some disadvantages since there is no segregated bike lane and therefore, cyclists share the space with all of the other vehicles. The speed of the vehicles was noticed to be higher than the speed permitted, in many cases mainly due to the ample

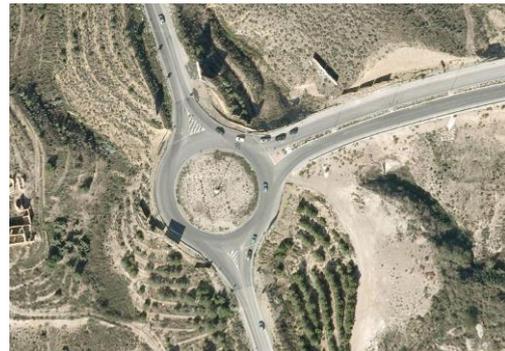
Given that the two housing developments are obviously residential, the habitual traffic is found in the early morning, at midday and late in the evening, coinciding with the times when people go in to and get off work. Notwithstanding, there is a large increase at the weekends given the very high attraction of the shopping centre with very elevated peak times if there are football matches.

As far as the geometric characteristics, the diameter is small, there are two driving lanes, three entry/exit slip roads, no traffic lights and a rather elevated longitudinal slope. The artificial lighting, signing, cleanliness and maintenance are considered to be adequate.

From a cyclist's perspective, there is no segregated bike lane or specific signing. It happens that there is a large number of cycling groups in the two housing developments the road gives access to which produces high bicycle traffic through the intersection either in groups or individually.

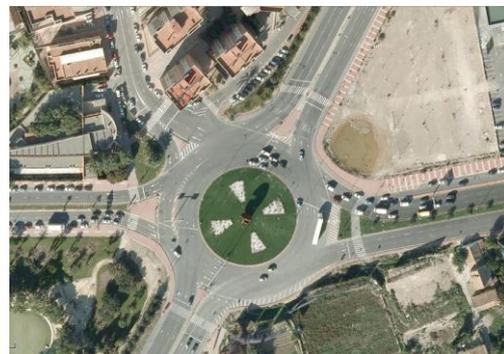
It is a large roundabout, situated in the intersection of two of the main avenues in the urban area which are avenida Ronda Sur and avenida de Los Dolores. One of the entry slip roads (from Ronda Sur) creates a rather high slope which means many vehicles enter at an excessive speed. The other entry slip roads from Ronda Sur and avenida de Los Dolores feature a normal longitudinal slope although the number of lanes and turning radiuses at the entrances also generate confidence in drivers which can likewise cause excess speeds at the entrances.

It is a completely urban intersection with the resulting characteristics of the existence of pavements, traffic lights, pedestrian crossings and very intense traffic throughout the entire day with occasional much more intense peak hours. There are five driving lanes and five entry slip roads, some of them very close together. The roundabout features an adequate longitudinal and cross-slope and very good visibility. The state of conservation and maintenance is also adequate as well as the signing.

The confluence of important roads is such that there are no predominant movements; they are all constantly used at the same time. This situation generates a large number of inner crossings to such extent that channelling was created inside the roundabout to separate some movements from others.

There are some disadvantages from a cyclist safety perspective which are basically the excess speed mentioned above (when a vehicle enters the roundabout when the light is green) and the constant vehicle movements on the inside. There is also another circumstance due to slip roads that are very close together. The traffic lights occasionally produce an accumulation of vehicles stopped on the inside waiting for the green traffic light that affects all of the other movements.
